EVALUATION OF  
CITY OF BOSTON  
PARK AND RECREATION LAND

NEIGHBORHOOD OF CENTRAL  
(CHINATOWN, DOWNTOWN, NORTH END)

Prepared for  
MAYOR'S OFFICE  
OF  
CAPITAL PLANNING

THE HALVORSON COMPANY, INC.  
LANDSCAPE ARCHITECTS AND  
SITE PLANNING CONSULTANTS  
161 MASSACHUSETTS AVENUE  
BOSTON, MASSACHUSETTS 02115

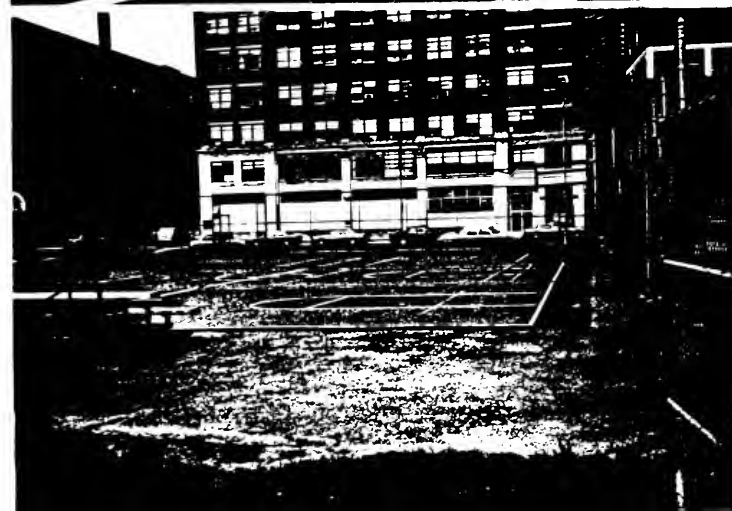
**Site Photograph 3**

Two basketball and one tennis court.

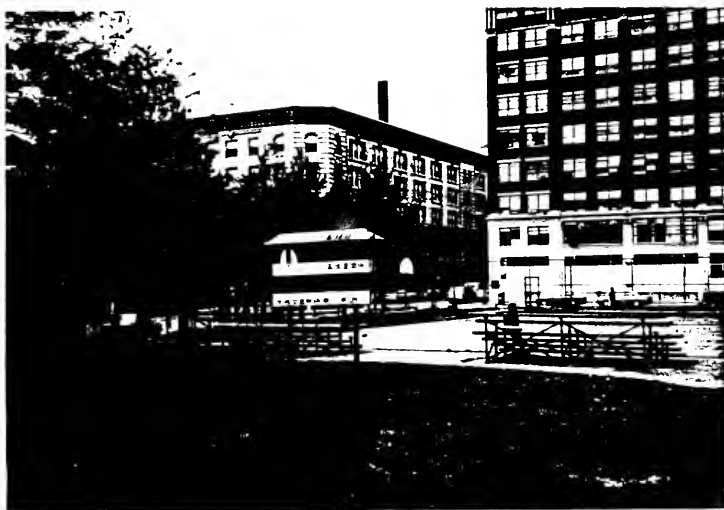
**Site Photograph 4**

Pagoda Park sign.  
Good strong tree  
planting along street  
edge.

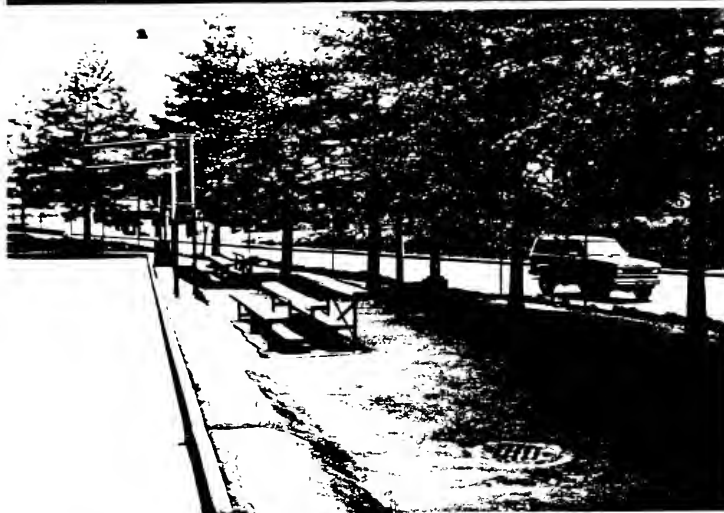
**Site Photograph 5**

View shows proximity of  
park to ramp. Trees  
are good partial screen.

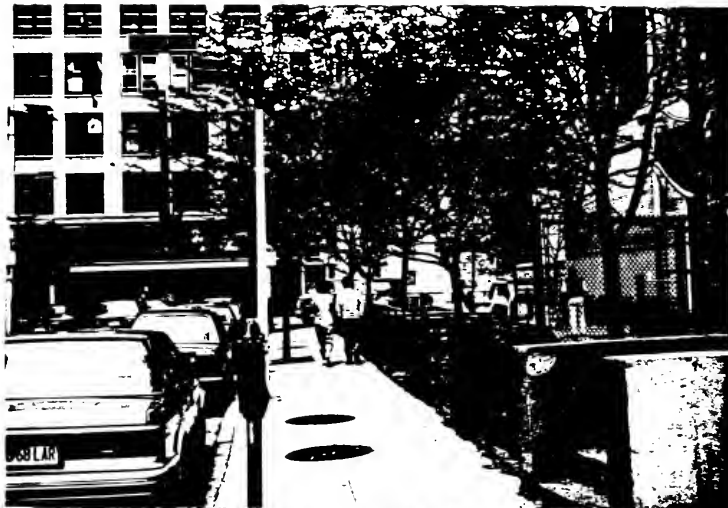
**Site Photograph 1**

View along edge of park on Hudson Street-- shows chinese character of fencing in keeping with character of neighborhood.

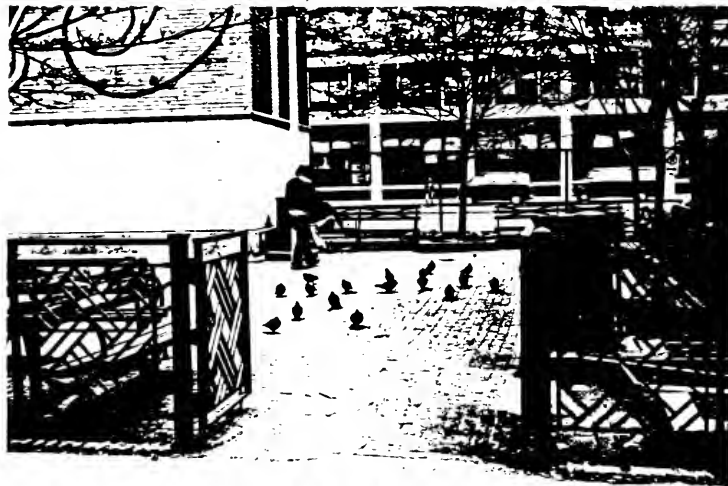
**Site Photograph 2**

Entry into park with seating and trees around edge. Noise and fumes from surface artery behind impact this park.

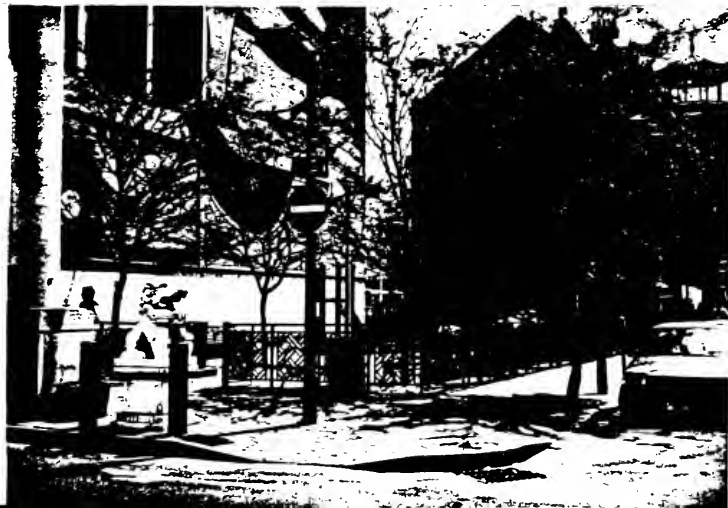
**Site Photograph 3**

Shows location of park next to gateway into Chinatown. Locust tree planting provides filtered shade.

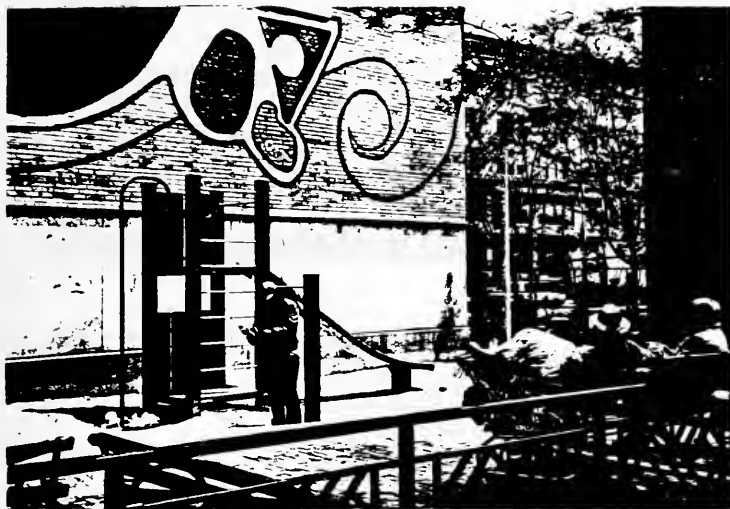
**Site Photograph 4**

Playlot with mural  
behind.

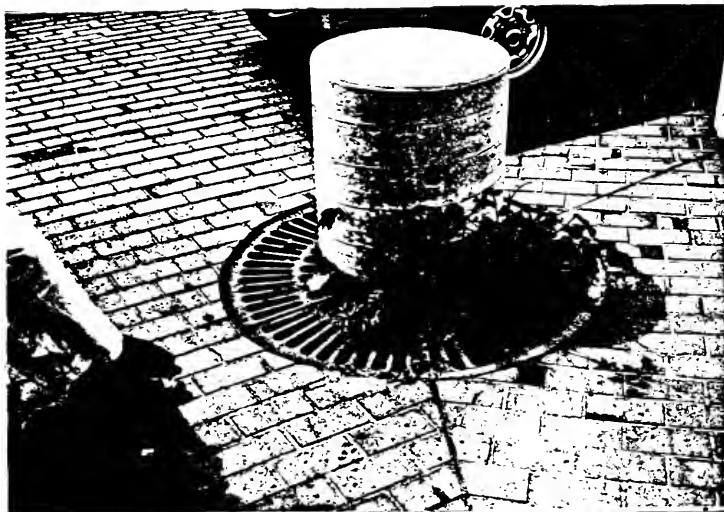
**Site Photograph 1**

Weed trees around base of bollard should be removed as soon as possible before developing into larger more difficult to remove size.

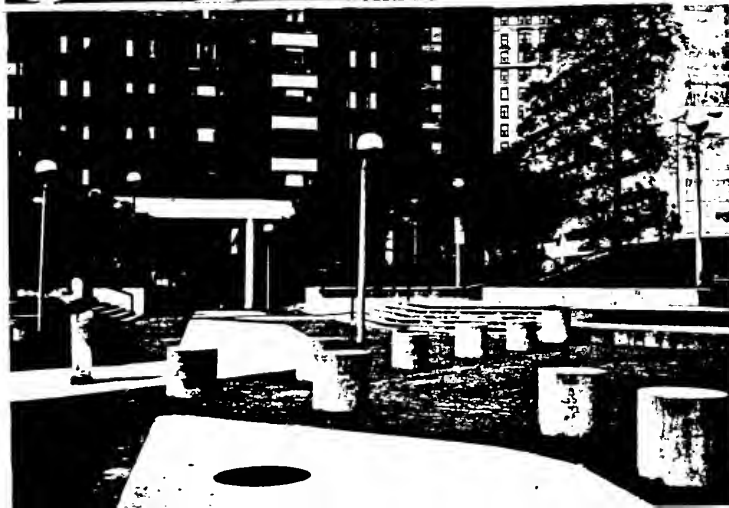
**Site Photograph 3**

View through center of site.

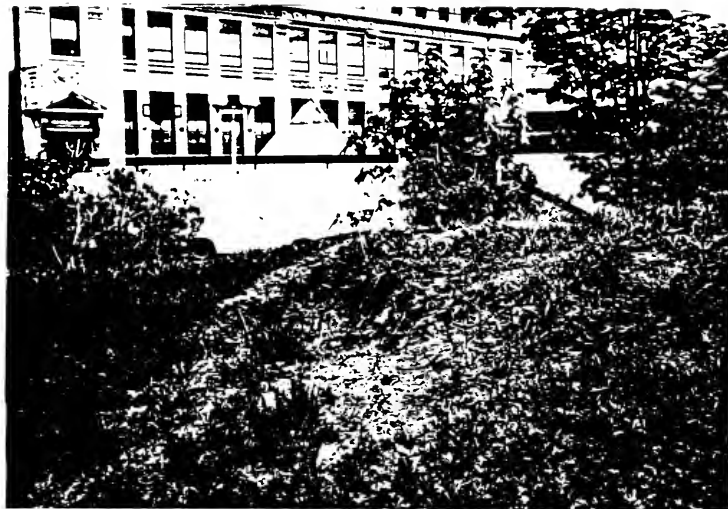
**Site Photograph 4**

Berms too steep in some areas to maintain grass. This is location of a tree that died, possibly as result of water draining too rapidly away from tree roots.

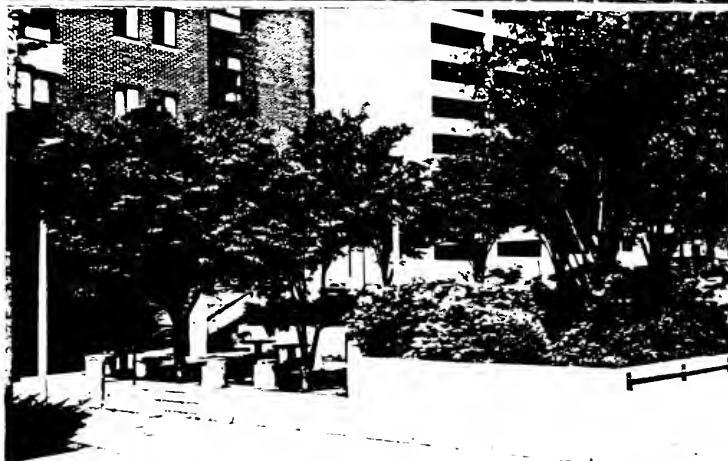
**Site Photograph 5**

Seating and game table with shade trees and shrubs.

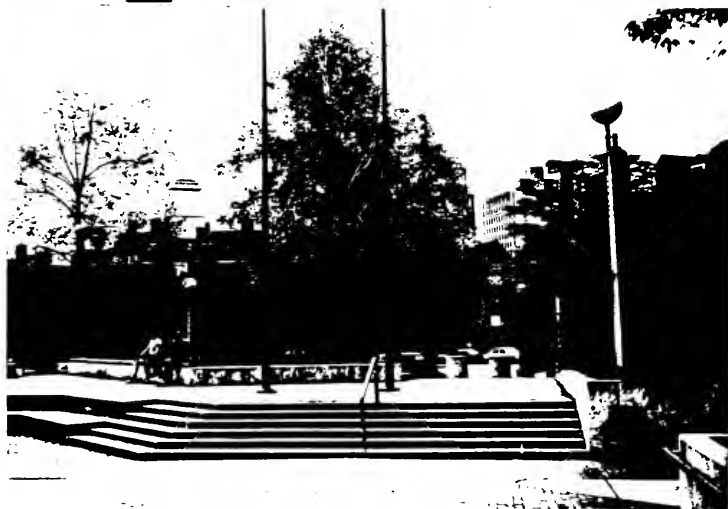
**Site Photograph 6**

Access way through site. Note sparse foliage on trees to left.

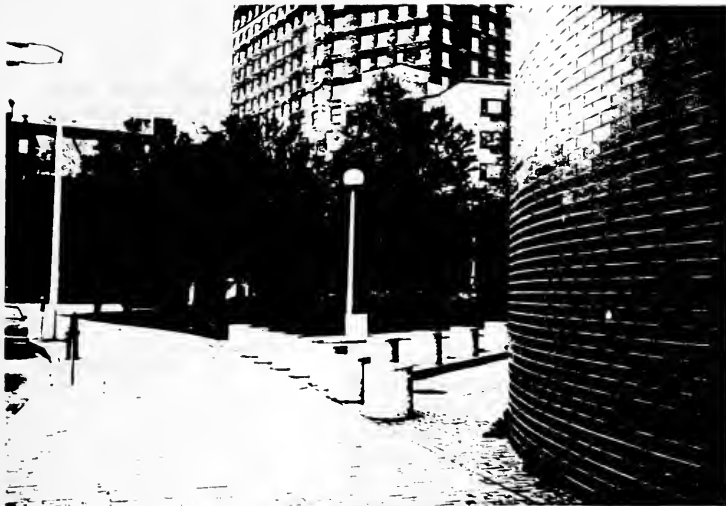
**Site Photograph 7**

View along edge of site  
along Charles Street.

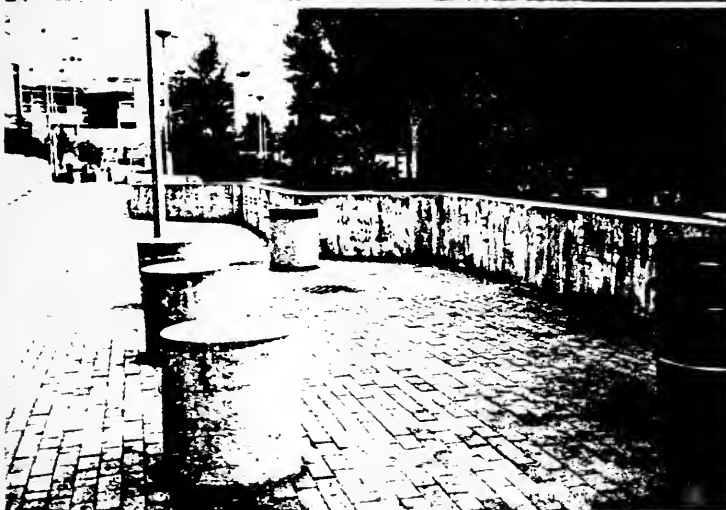
**Site Photograph 8**

Benches removed from  
concrete wall.

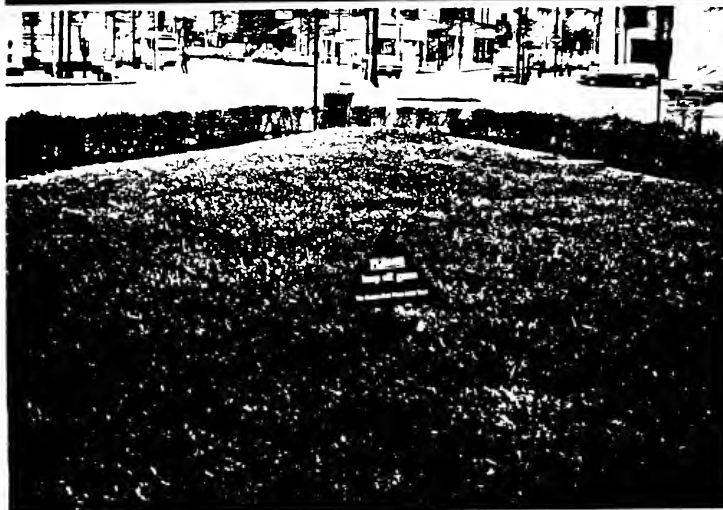
**Site Photograph 2**

Well-maintained grass.

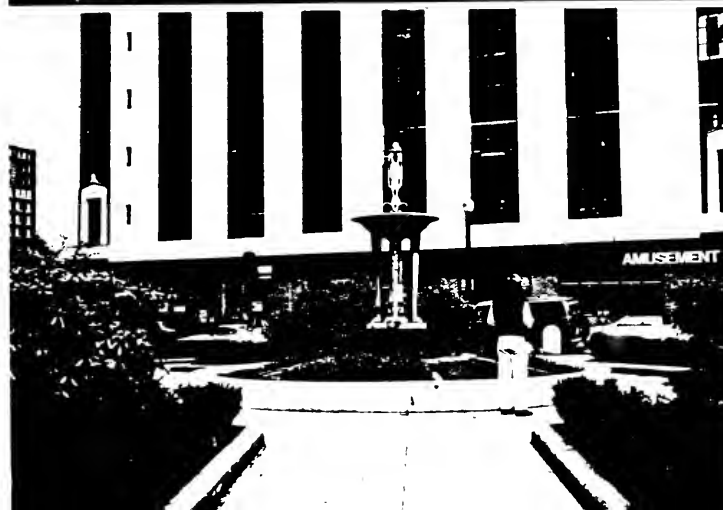
**Site Photograph 3**

Statue as focal point and planting at base.

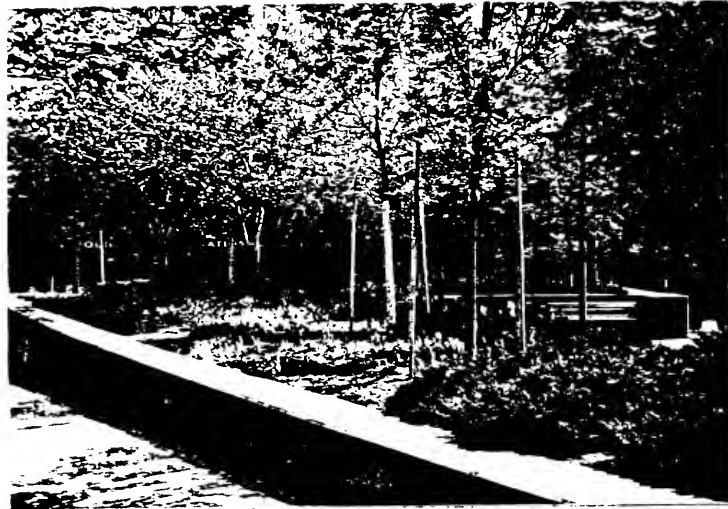
**Site Photograph 4**

Trees, shrubs and weeds in raised planters.

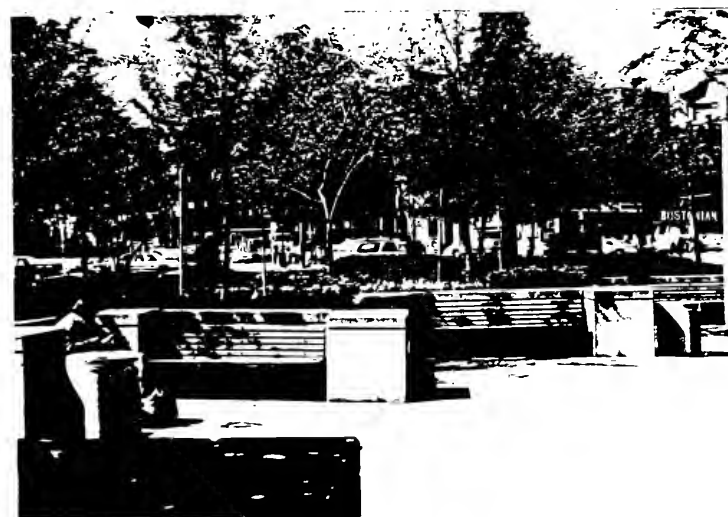
**Site Photograph 6**

Benches and trash receptacles along inside edge of planters.

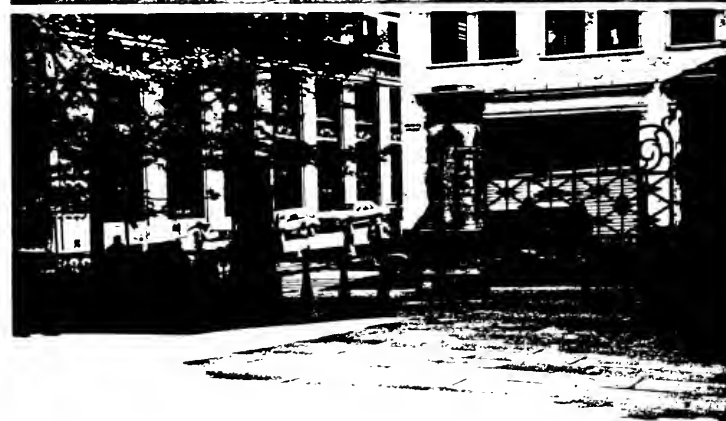
**Site Photograph 3**

Bluestone paved  
entry court with  
granite and cast  
iron gates.

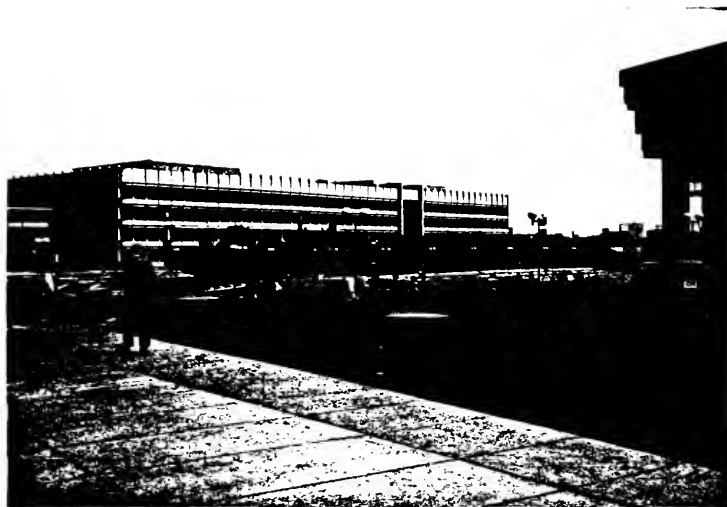
### Site Photograph 1

View into plaza from Cambridge Street shows large scale and restricted use of trees.

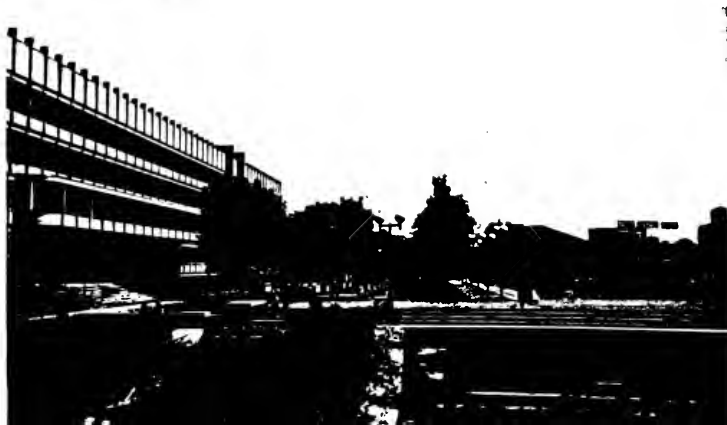
### Site Photograph 3

View across site towards sitting area with trees.

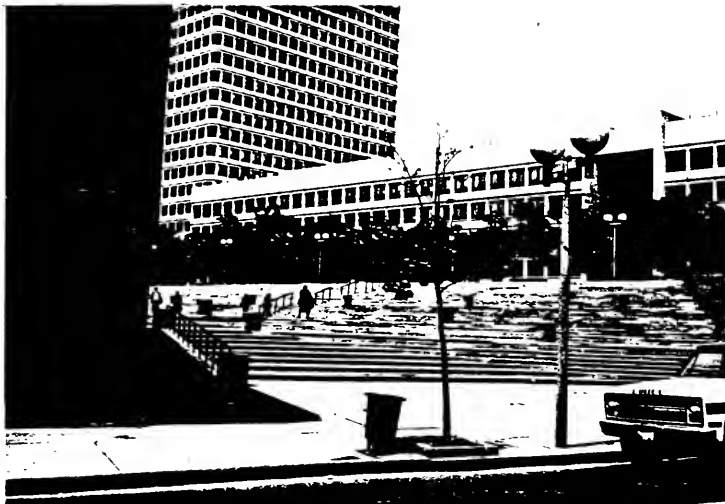
**Site Photograph 4**

Looking into site from New Congress Street at amphitheater seating. Trees provide a good green edge with J.F.K. Building behind.

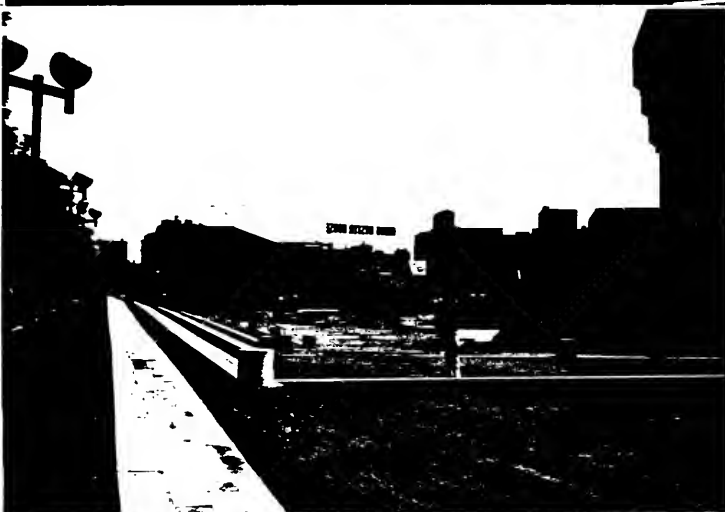
**Site Photograph 5**

View down into amphitheater.

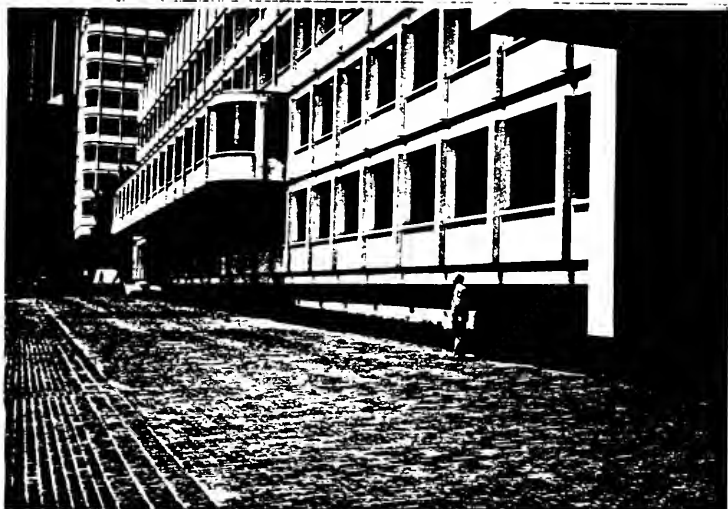
### Site Photograph 7

View along edge of J.F.K. Building. Minimal planting along edge.

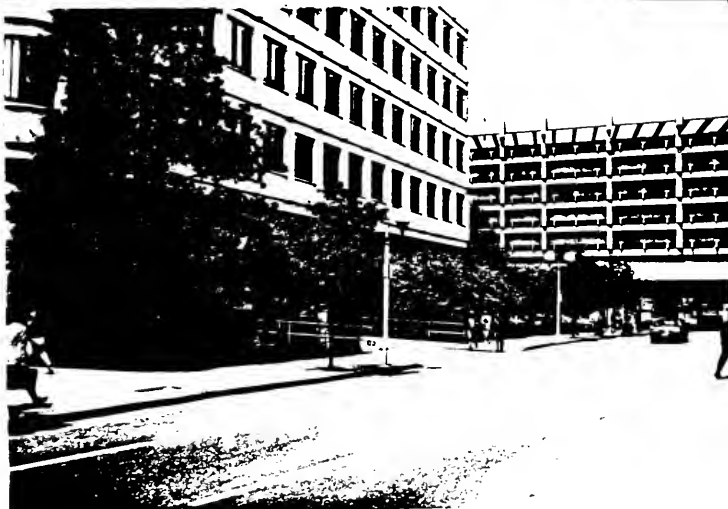
### Site Photograph 9

Face of J.F.K. Building and planting along New Cambridge Street. Shade and flowering trees, shrubs and lawn generously planted and well maintained.

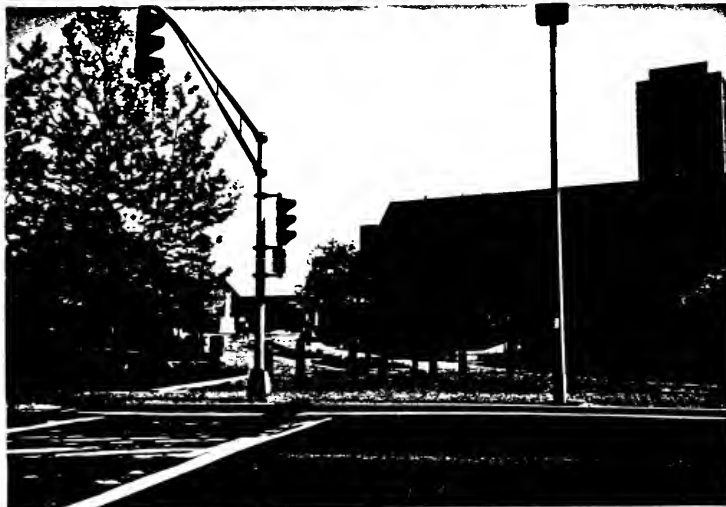
**Site Photograph 2**

Main entrance from  
Atlantic Avenue with  
statue of Columbus at  
far end.

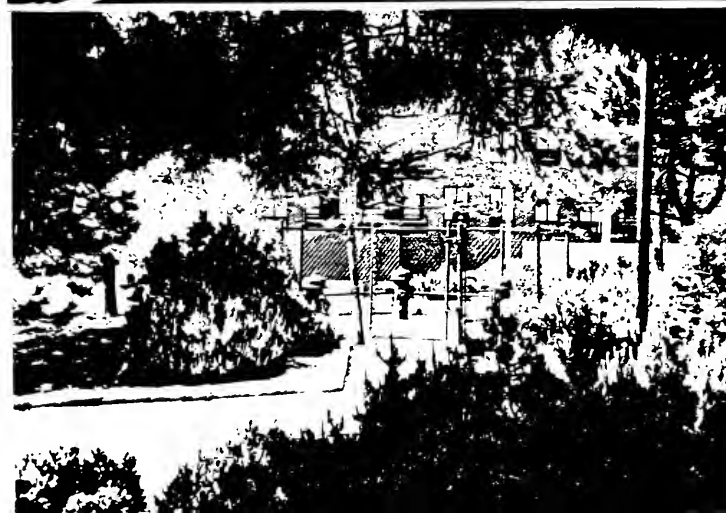
**Site Photograph 3**

Area for dog use. Also  
shows mature shrub  
planting.

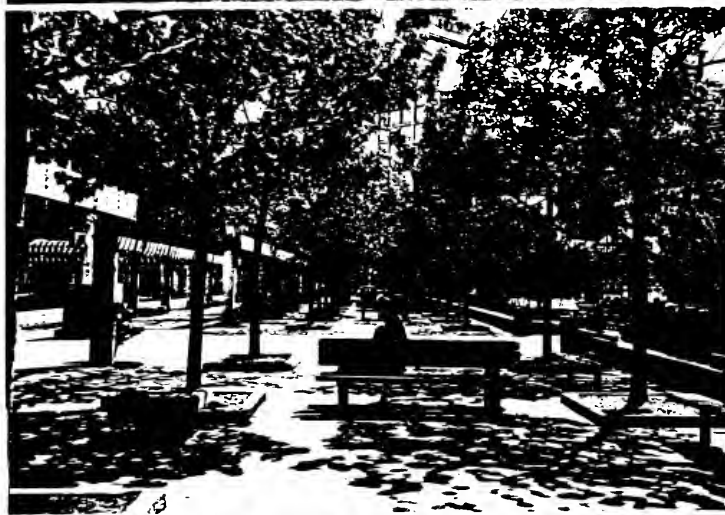
**Site Photograph 5**

Shade tree planting with seating. Trees planted close enough to create a complete canopy overhead-- shades and cools paved surface, improves growing conditions.

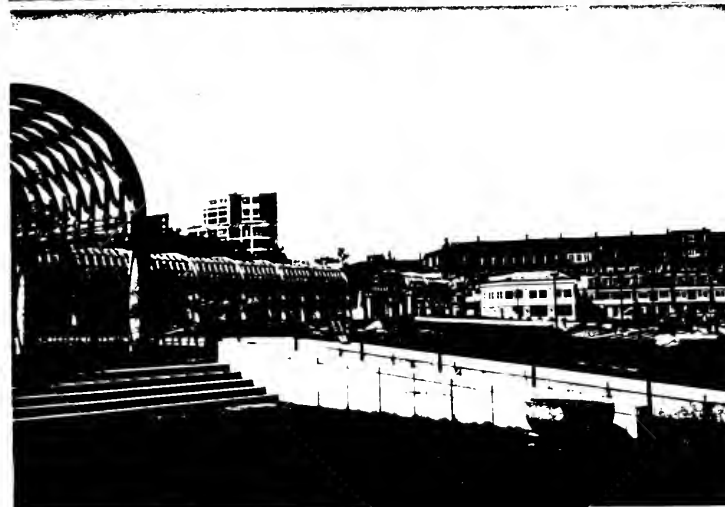
**Site Photograph 6**

Wheel chair ramp in foreground. Grassed bank oriented towards harbor.

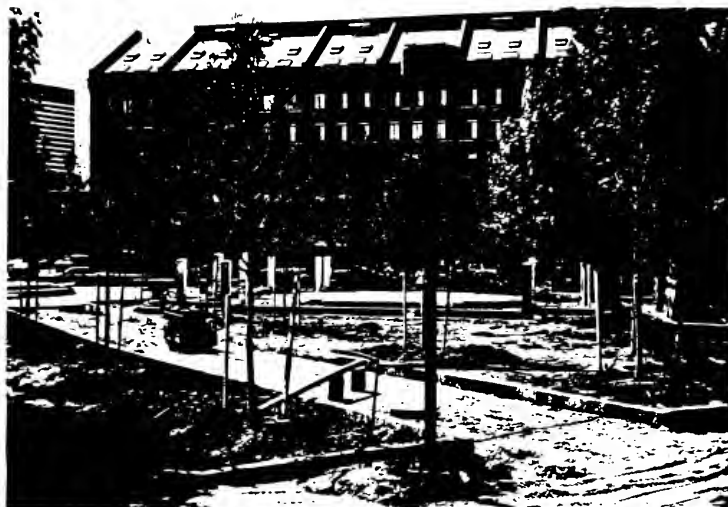
**Site Photograph 7**

Area under construction--  
future rose garden.

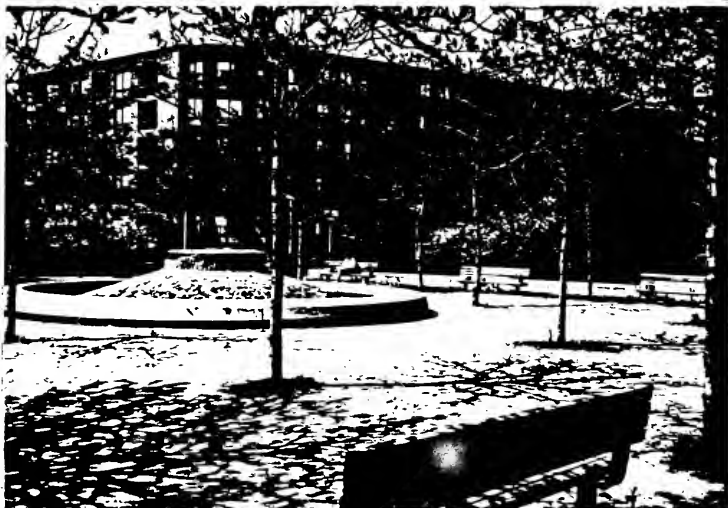
**Site Photograph 8**

Fountain surrounded by  
trees. Stonedust  
walking surface.

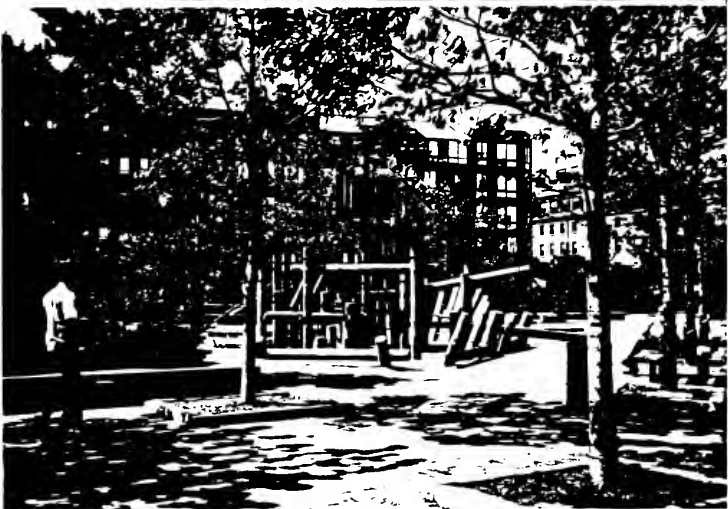
**Site Photograph 9**

Playground-- timber  
climbing structure  
with nautical character.

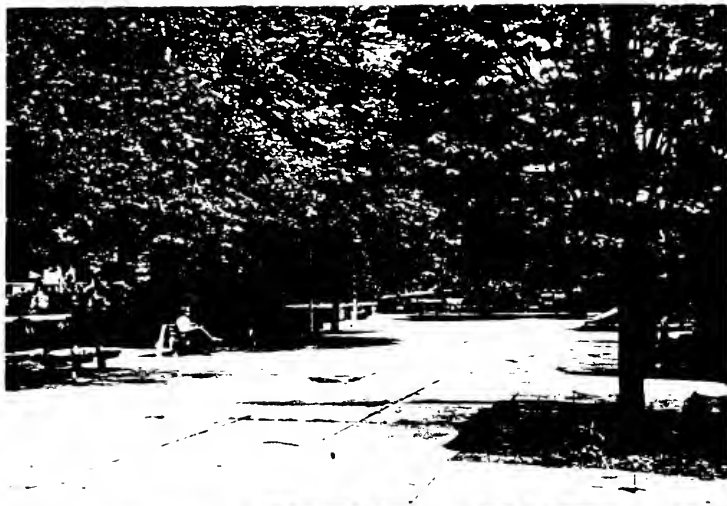
**Site Photograph 4**

Upper level terraced area for sitting. Graffiti on sidewalk, weeds.

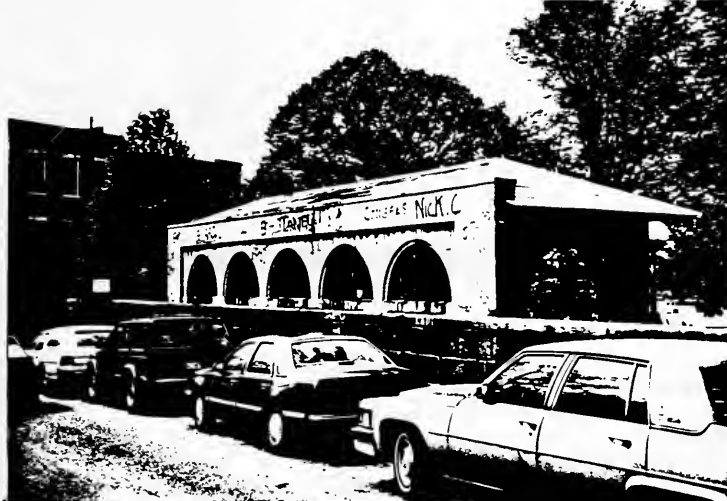
**Site Photograph 7**

View of shelter from Charter Street. In need of complete renovation.

All standard park-built elements including walls and stairs are in good condition except for the shelter building which has been burned and is in need of renovation. Most of the plantings are in good condition, however guy wires have not been removed from the trees. Some areas of grass are in poor condition, although most are in fair condition. There are numerous trees that have seeded themselves into the park and need to be removed.

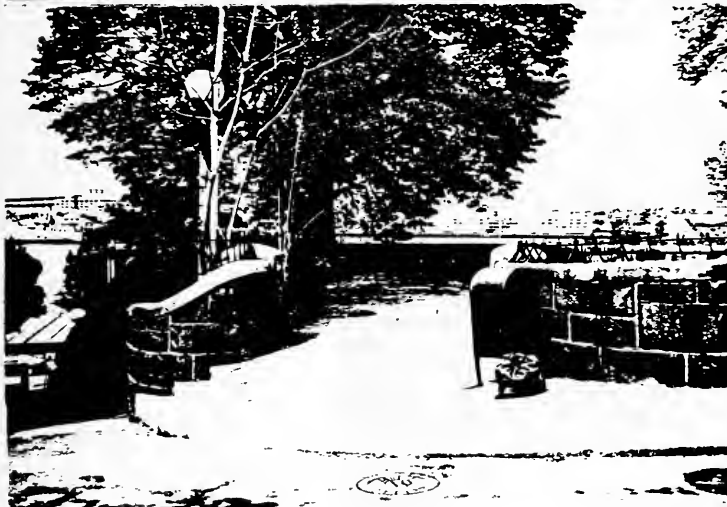
**Site Photograph 8**

Entrance from Charter Street, poor location for mail box. Weed trees need removal. Shows excellent view of harbor from this site.

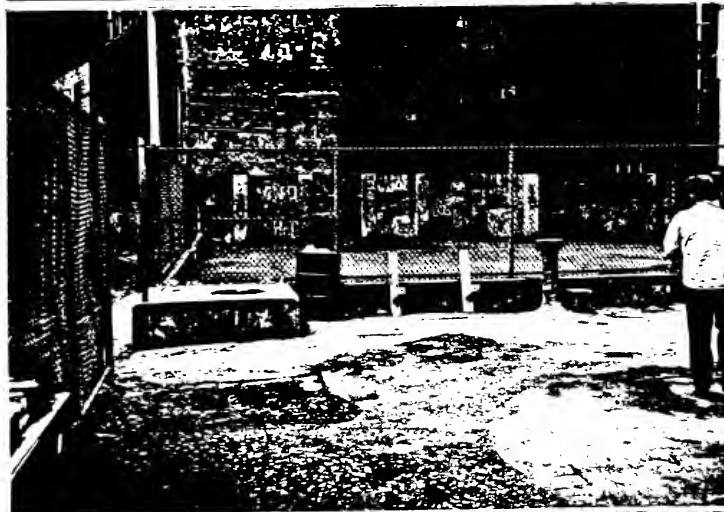
**Site Photograph 2**

Extreme vandalism-- benches destroyed, graffiti-covered walls, trash and weeds.

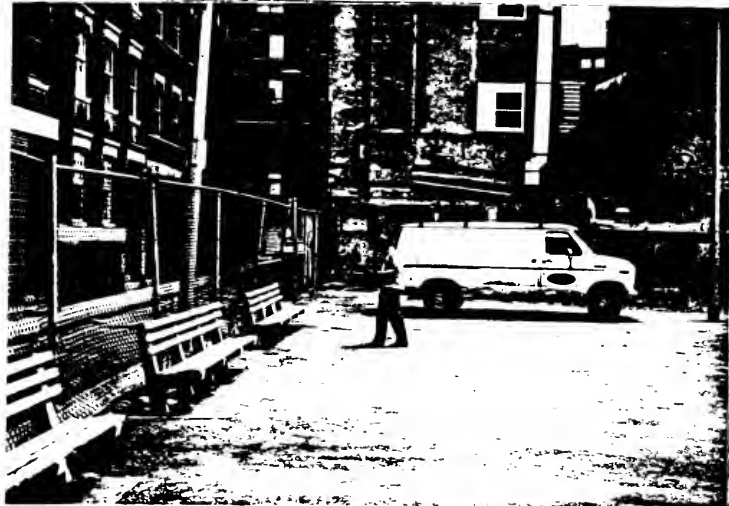
**Site Photograph 4**

Entirely paved passive  
use area--  
inappropriately used  
as parking.

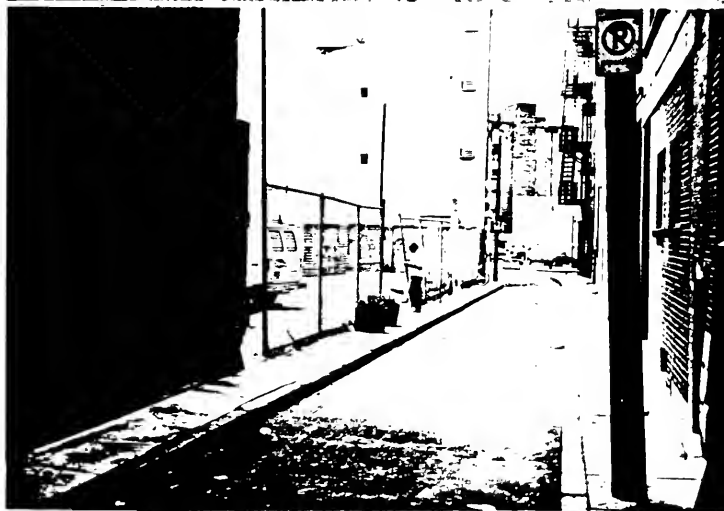
**Site Photograph 6**

Stillman Street edge  
of park dominated by  
chain link fence.

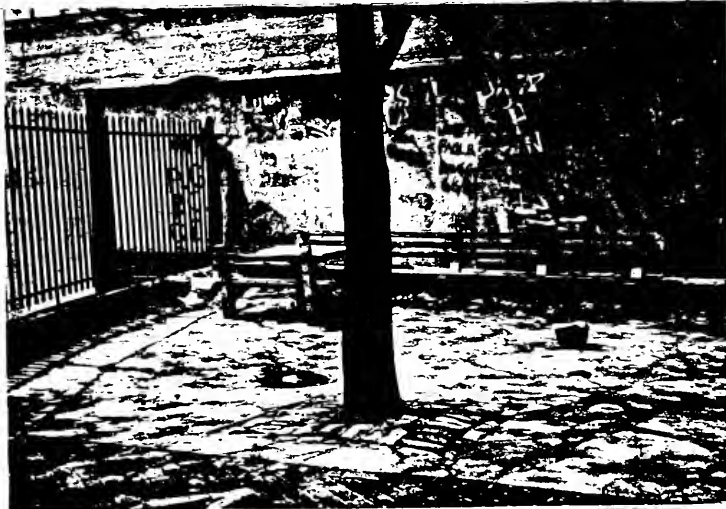
**Site Photograph 2**

Upper level sitting area-- graffiti and litter make park extremely uninviting.

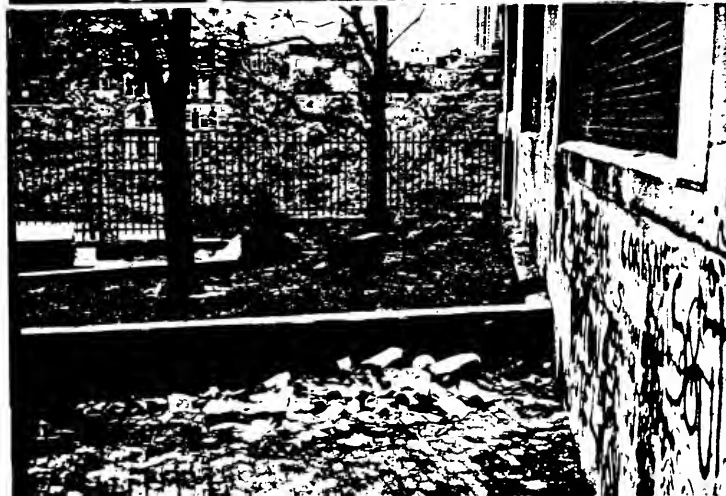
**Site Photograph 3**

Piles of trash. Weeds in planting beds.

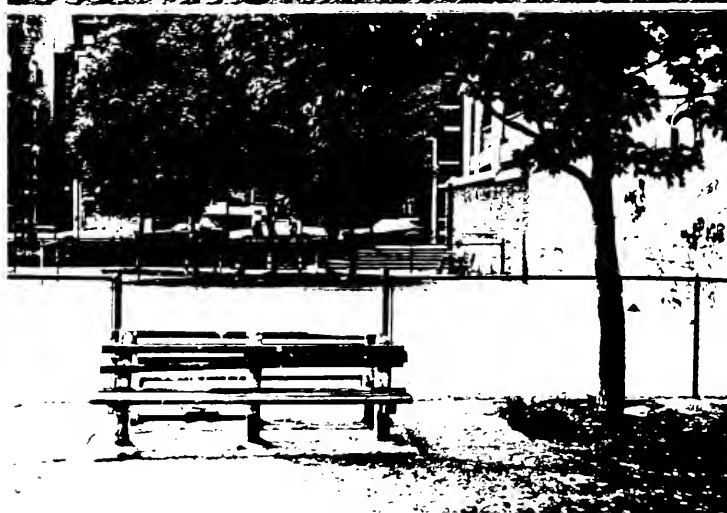
**Site Photograph 6**

Shaded sitting area--  
Norway Maples doing  
well despite limited  
growing space.

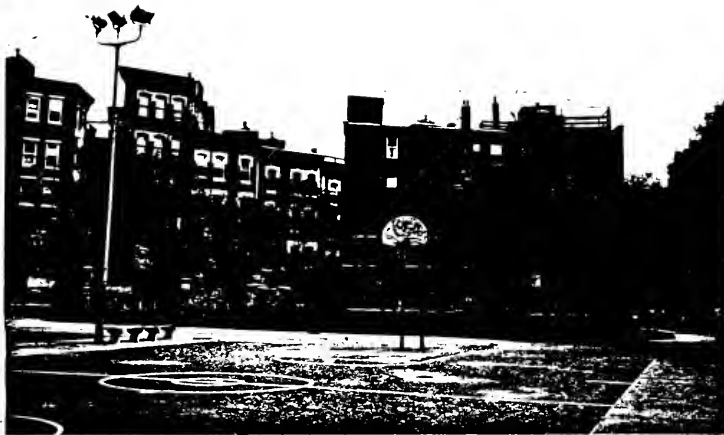
**Site Photograph 7**

View across basketball courts. Area of grass a refreshing contrast to paved surface.

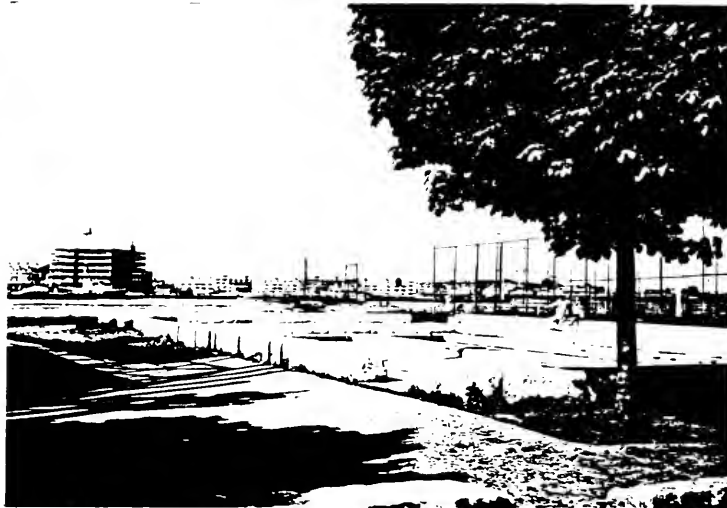
**Site Photograph 1**

Bocci courts.

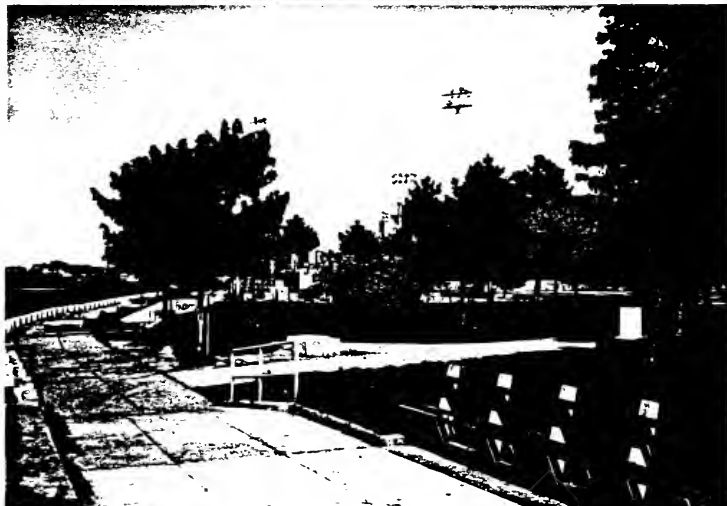
**Site Photograph 8**

Variety of plant materials by playground.

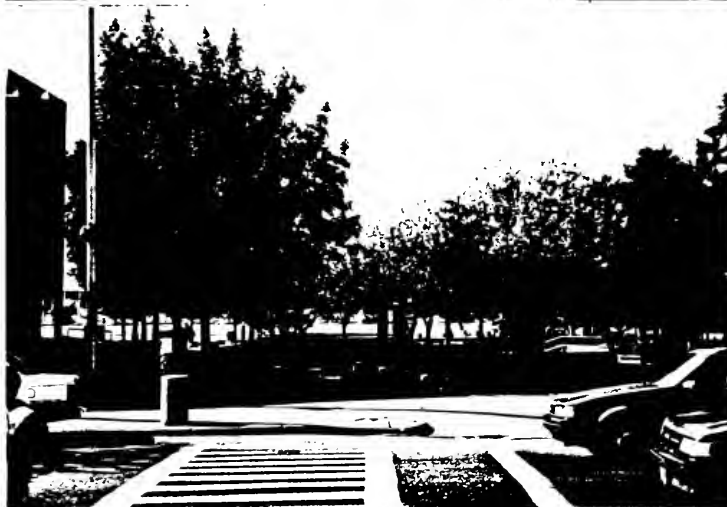
**Site Photograph 9**

Shade and flowering trees mark entrance into park.

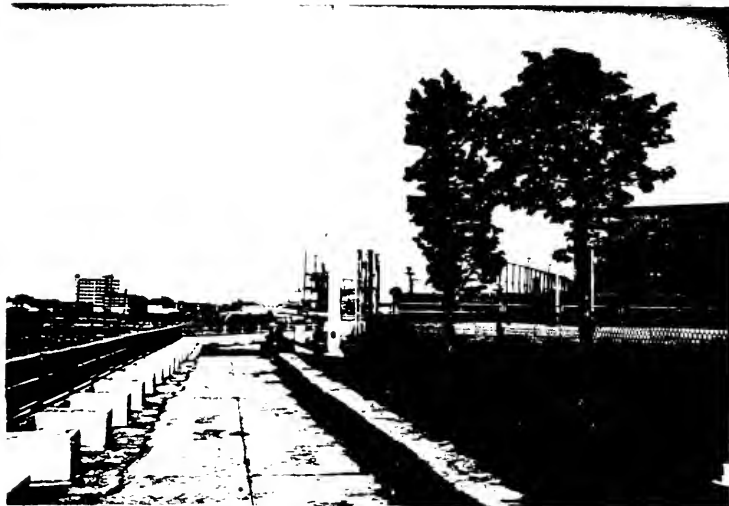
**Site Photograph 4**

Promenade along  
waterfront with granite  
sitting wall.

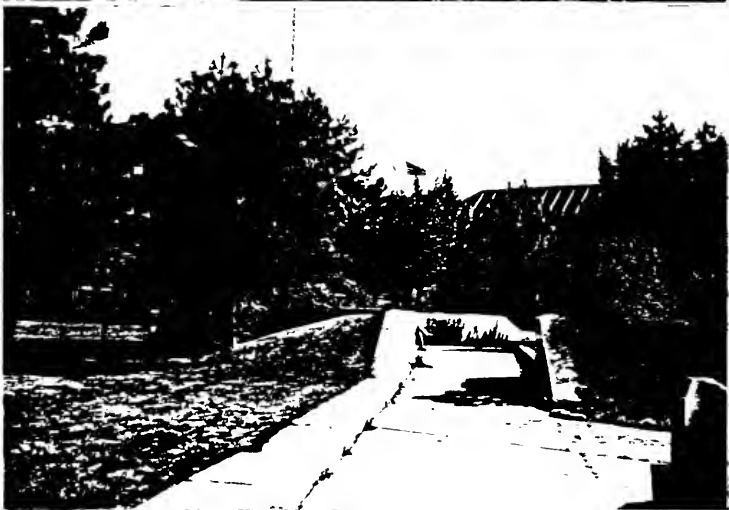
**Site Photograph 6**

Entry into play area.  
Berming and tree massing  
help to screen play area  
from wind.

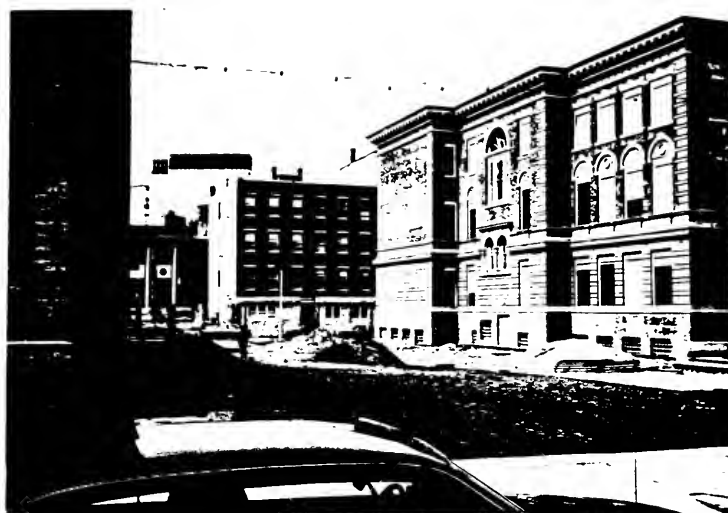
**Site Photograph 1**

View into site--  
currently under  
construction.

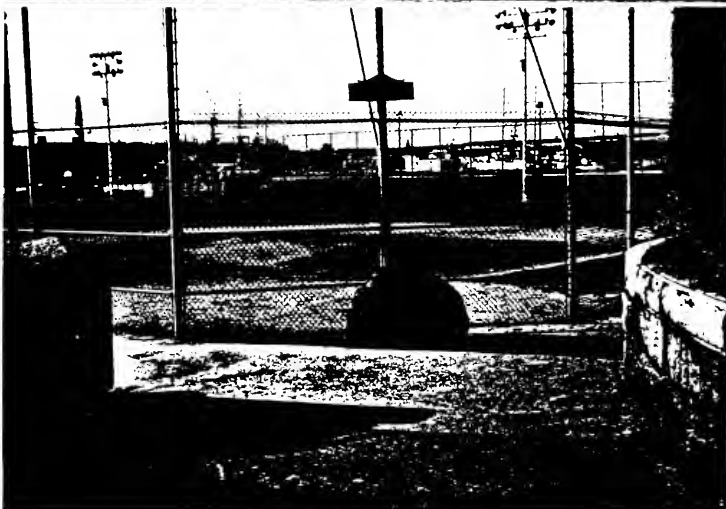
**Site Photograph 4**

Condition of fence and weed growth along base very poor. Infield mix located in area of pedestrian access.

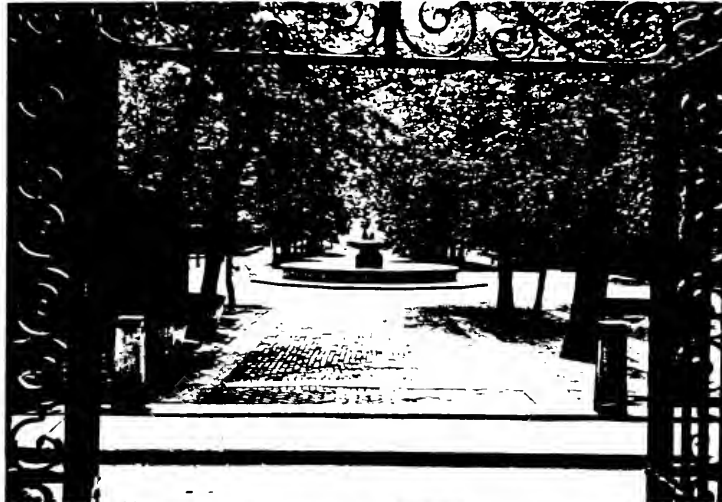
### Site Photograph 1

View into park, showing fountain as focal point and strong formal planting plan. Two flower planters at left.

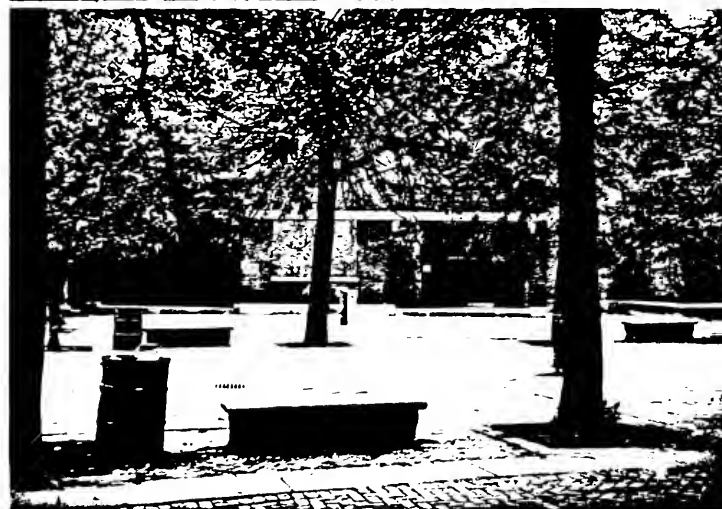
### Site Photograph 3

Public restrooms closed.

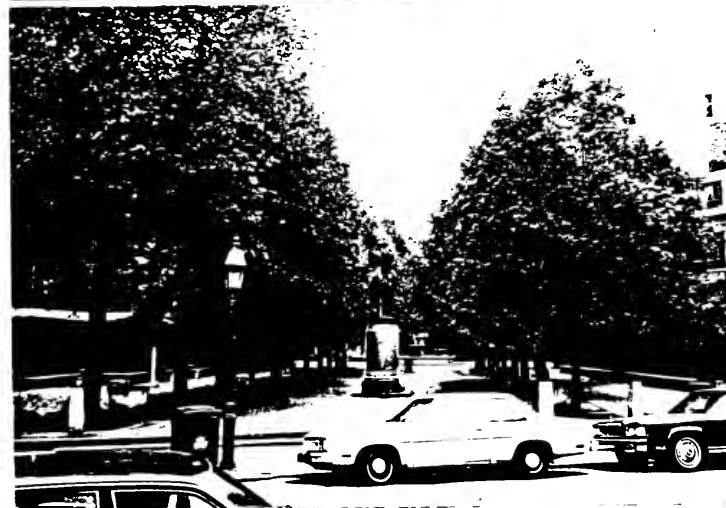
#### Site Photograph 6

Most often seen view of this park with statue of Paul Revere in center.
